Re: Geotechnical Observation and Testing – Final Report
Kelok Way Dewatering Wells, Clayton, CA
SFB Project No.: 555-1

Kelok Way Wells Layout "As-Built"
 Clayton, California
 (REVISED DECEMBER 10, 2012)

Figure 2, Photo of Collector Box Interior

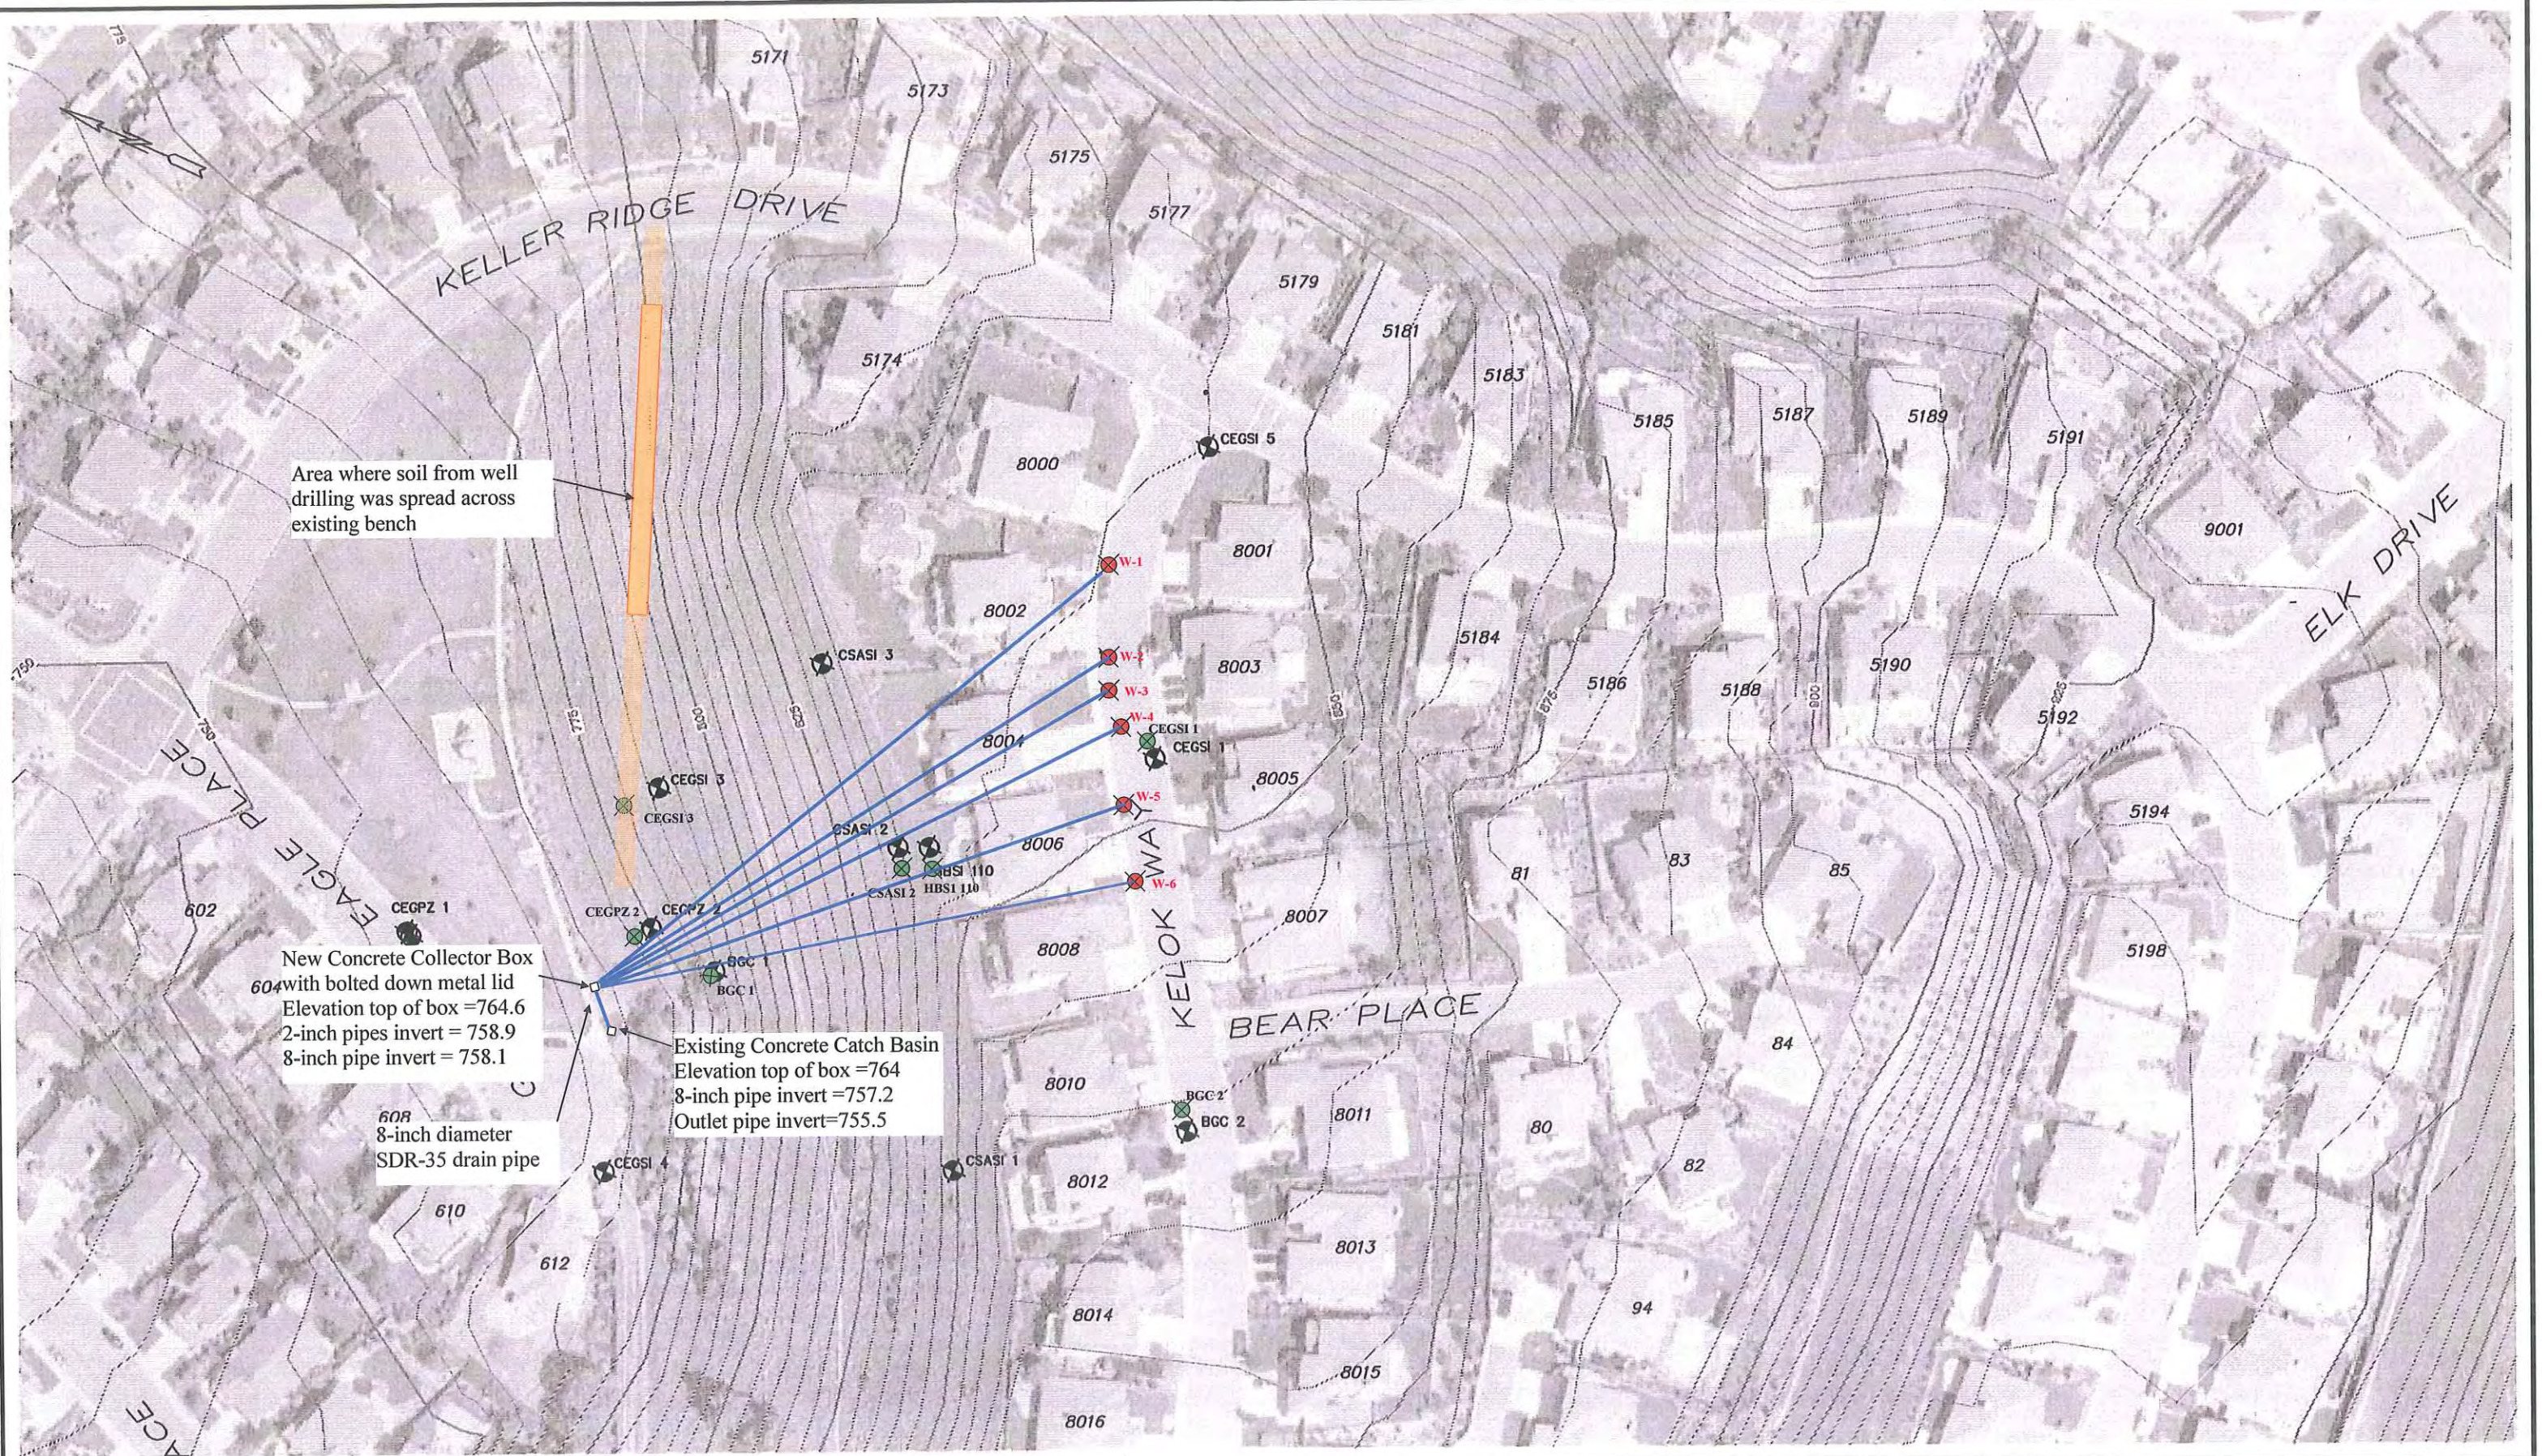
An as-built plan was prepared by ESR showing the approximate locations of the recently installed wells, discharge pipes, and collector box. The as-built plan also shows the surveyed locations of pre-existing inclinometers and piezometers. The new collector box was connected to a previously existing concrete catch basin using an 8-inch SDR-35 drain pipe. These features are shown on the attached Figure 1; the wells are shown on the figure as W-1 through W-6. A photo showing the locations of the well discharge pipes within the new collector box is attached as Figure 2. Appendix A includes copies of our field reports summarizing our observations during the construction of the dewatering wells and their associated discharge pipes. Appendix B includes laboratory and field compactions test results and copies of our field reports prepared during the backfilling of the horizontal drill pit and the placement of the collector box.

Area where soil from well drilling was spread across existing bench

New Concrete Collector Box
 60" with bolted down metal lid
 Elevation top of box = 764.6
 2-inch pipes invert = 758.9
 8-inch pipe invert = 758.1

Existing Concrete Catch Basin
 Elevation top of box = 764
 8-inch pipe invert = 757.2
 Outlet pipe invert = 755.5

Monuments that were surveyed with total station that are different than shown on original plans

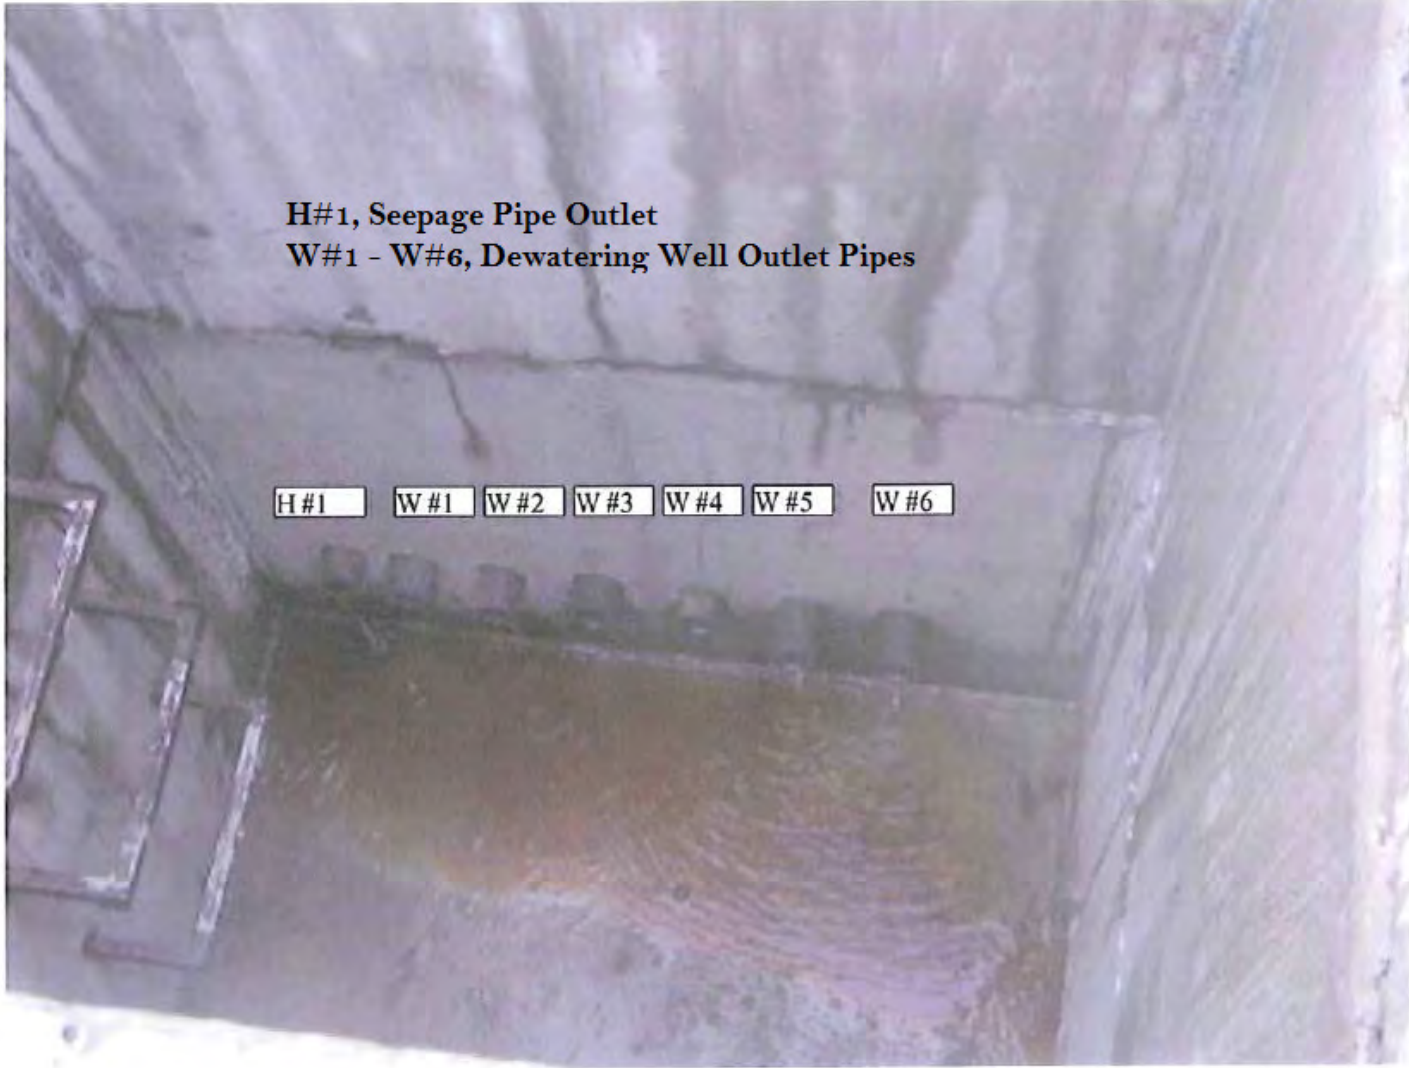
On November 9, 2012, we observed ESR routing the outlets of the six horizontal drain pipes to the new concrete collector box, and connecting the collector box to the existing concrete catch basin through a new 8-inch PVC pipe. A drain pipe that was installed during construction to collect slope seepage at the drill pit excavation was also permanently connected to the collector box. The locations of the pipes are shown in the attached Figure 2. The drain pipe installed to collect seepage is labeled as H#1 in Figure 2.

5 and W-6. On November 29, 2012, discharge from the drain pipes in the new collector box was also observed, with Drains W#5 and W#6 exhibiting a stream of water, Drain W#2 exhibiting a trickle of water, and the remaining drains showing dripping water. The cause of the lower flow rates is most likely related to the existence of the native fine sand in the area of the wells. As described previously, abundant native fine-grained, silty sand was encountered during the drilling of Wells W-1 through W-4 and their associated outlet pipes, but the fine sands were not encountered in significant quantities during the drilling of Wells W-5 and W-6 and their associated drain pipes. If these fine sands migrated into the Caltrans Class 2 permeable material surrounding the wells and/or the inlet of the drain pipes, the water flow from the wells to the drain pipes would be impeded. Water flows from the wells to the collector box can change over time as a result of several factors including changes in the subsurface conditions, ground water pressure, rainfall, and irrigation practices; therefore, water levels in the wells and flow rates in the drain pipes may increase or decrease over time.

H#1, Seepage Pipe Outlet
W#1 - W#6, Dewatering Well Outlet Pipes

We recommend regular maintenance of the recently installed drainage system include inspection and replacement of damaged well covers and caps, inspection of the collector box, and removal of debris from the collector box and associated storm drain pipe. If sediment accumulates in the wells, pumping of the sediment laden water can be performed in an effort to increase flow rates. We recommend the drainage system be made part of as-built plans in order to protect the system from potential construction related damage in the future.
