October 1, 2014
Job No. 2947.102

Subject: Slope Inclinometer Monitoring Program
Open Space Slope Below Lots 59 through 61
Pebble Beach Drive
Clayton, California

SITE PLAN

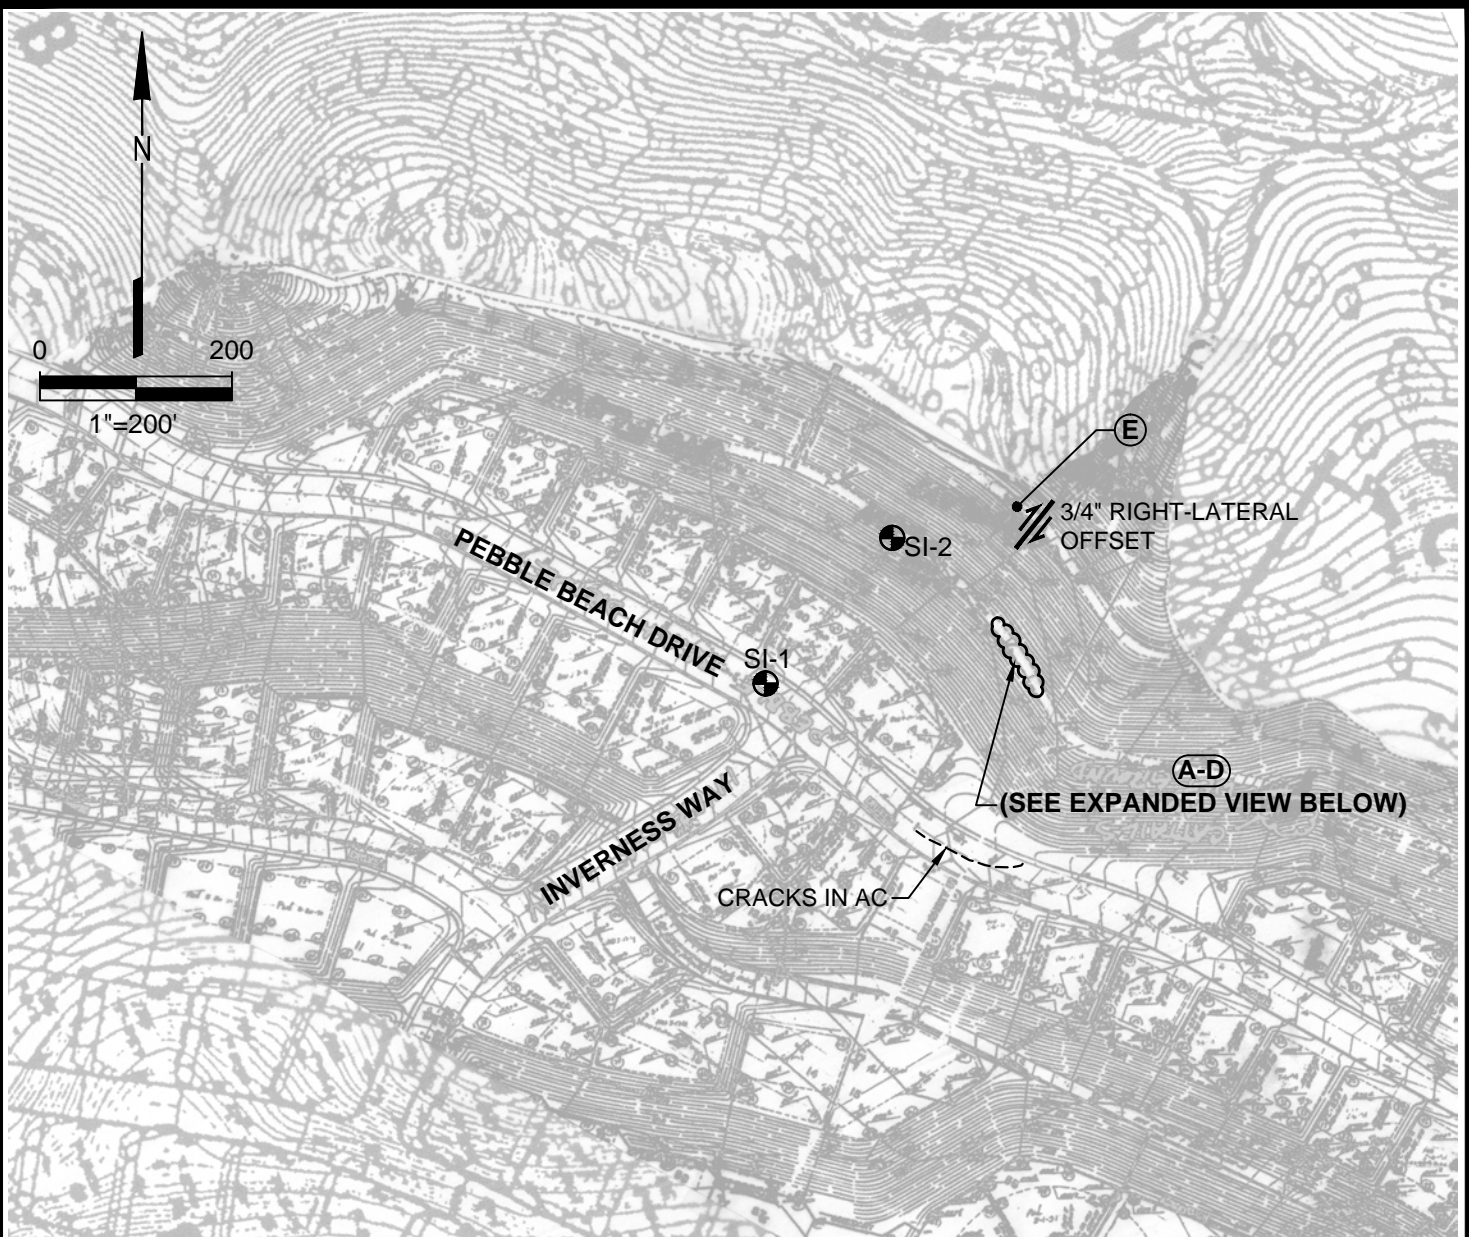
The V-ditches below Pebble Beach Drive were walked in the field. Observations by our engineering geologist indicate on-going movement over the last 4 years. See the attached Site Plan and photographs. The maximum apparent movement observed in the V-ditches is 3 inches at Crack B in the upper V-ditch.

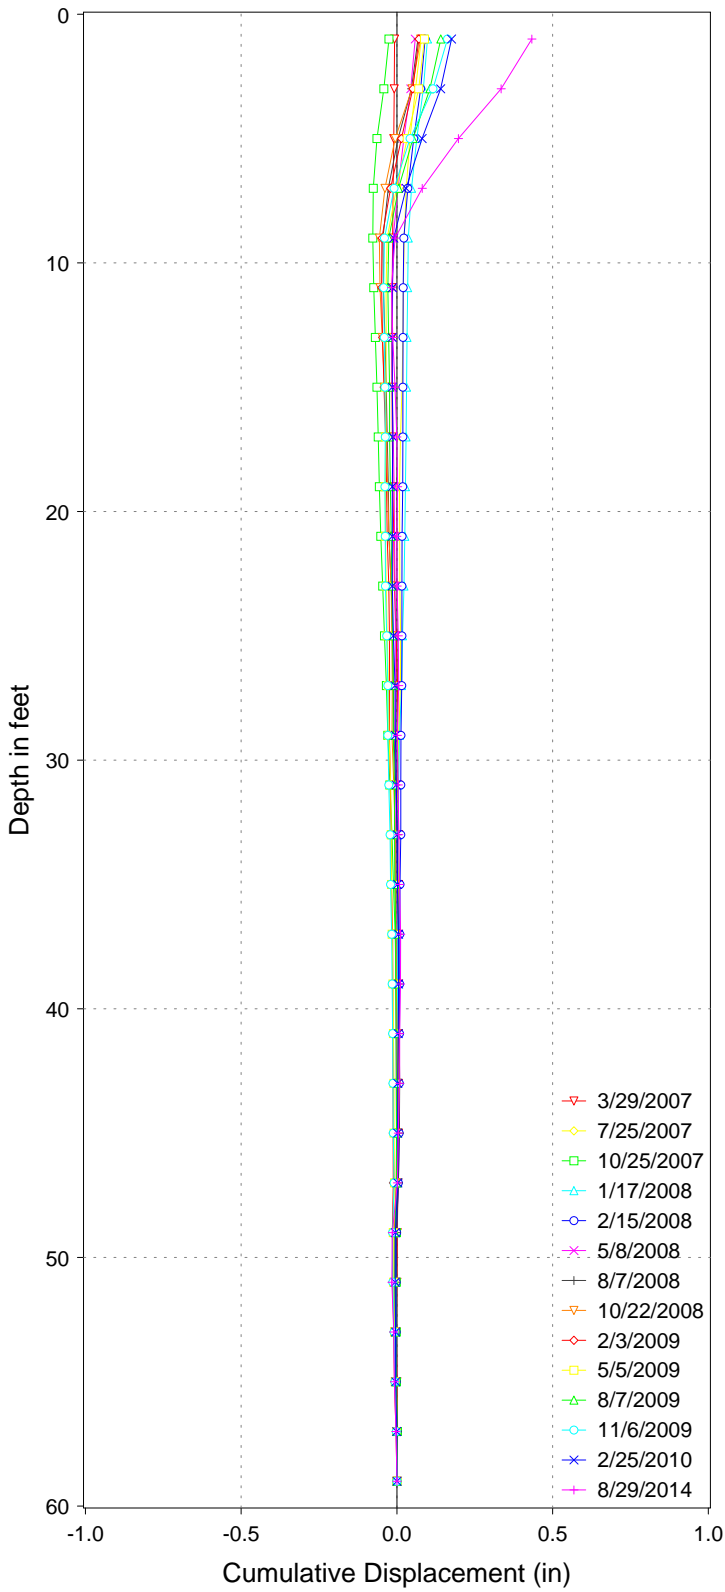
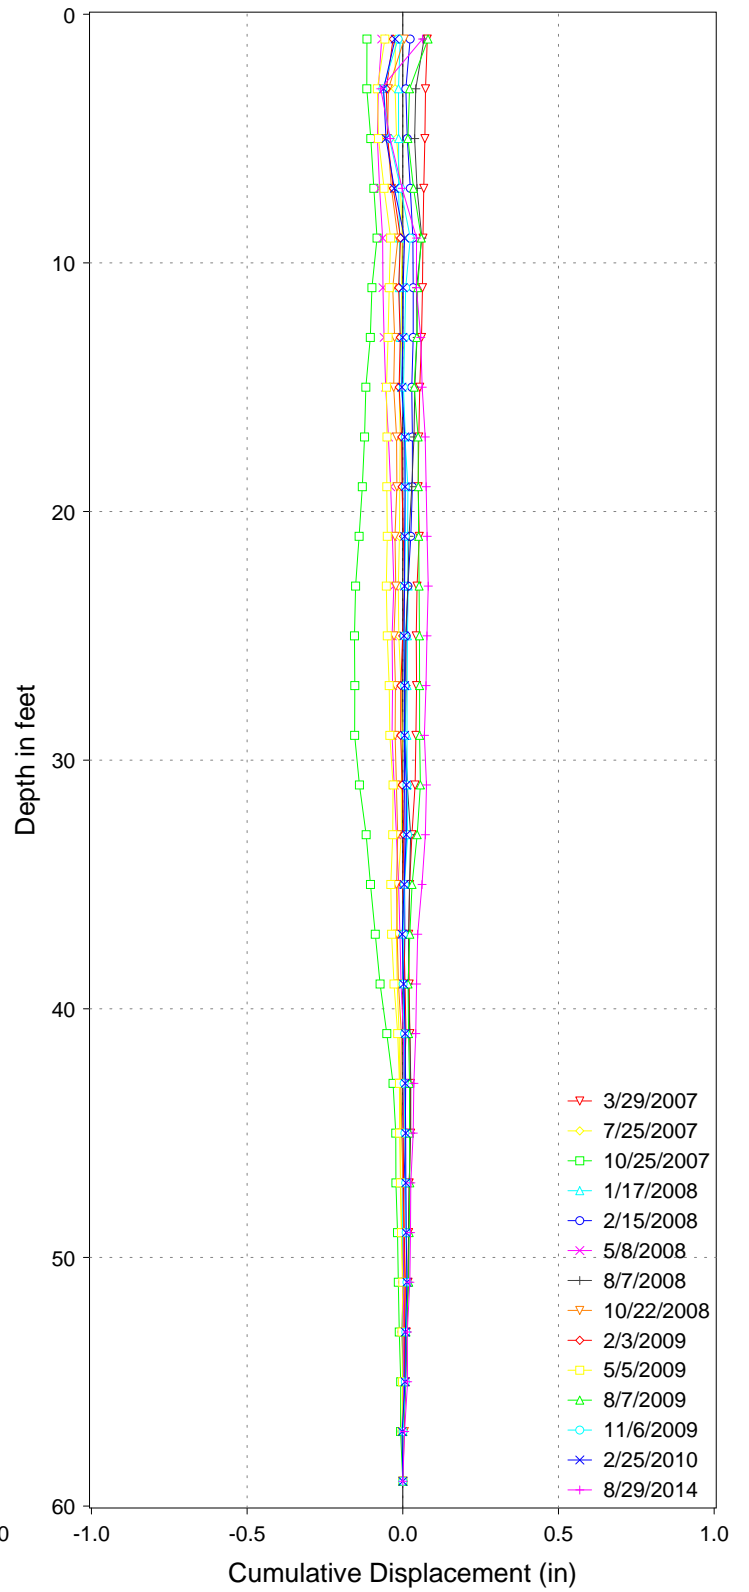
| SI-1 | Continued displacement between depths of 0 to 9 feet with maximum cumulative displacement of nearly 1 inch at the surface. |

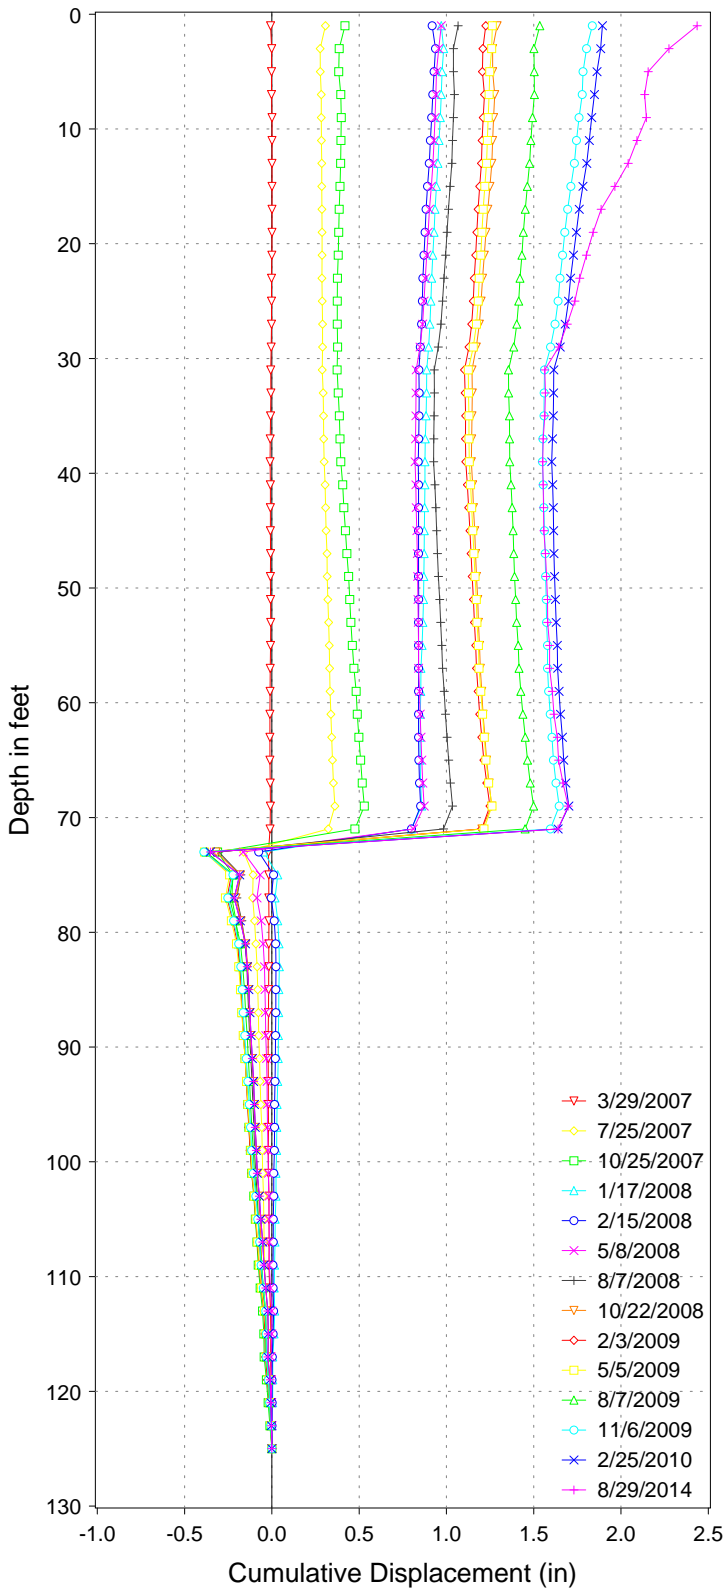
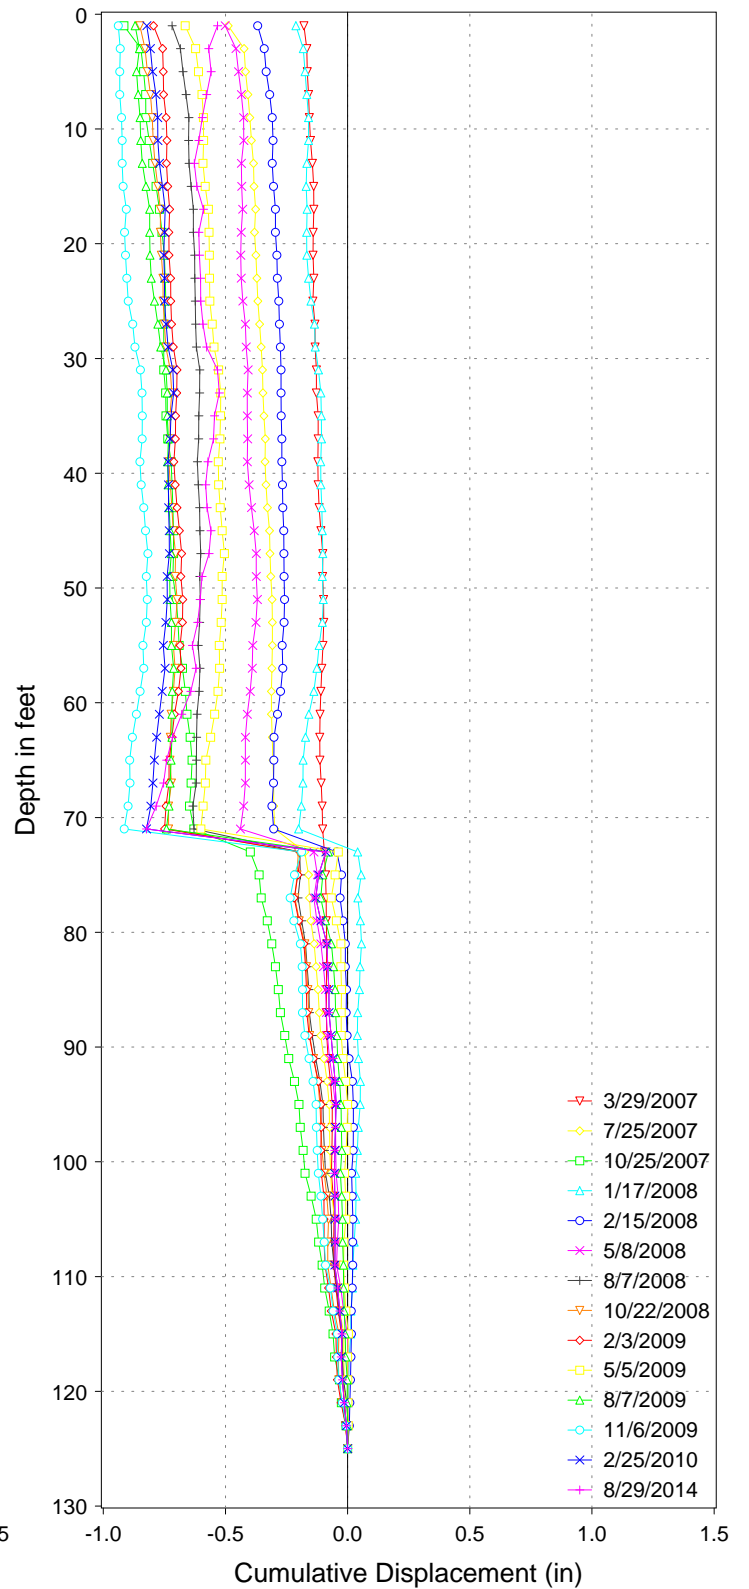
READING 8-29-14 REFUSAL AT 70 FEET

| SI-2 | The inclinometer casing has pinched at a depth of 72 feet. Therefore, we were unable to take readings between 72 feet and 125 feet in depth. To process the data collected in the upper 72 feet, we used the prior readings taken February 25, 2010 for depths of 72 to 125 feet to provide a data set for plotting purposes. The plotting suggests that the upper 72 feet is moving as a block, but the amount of movement is unknown. |

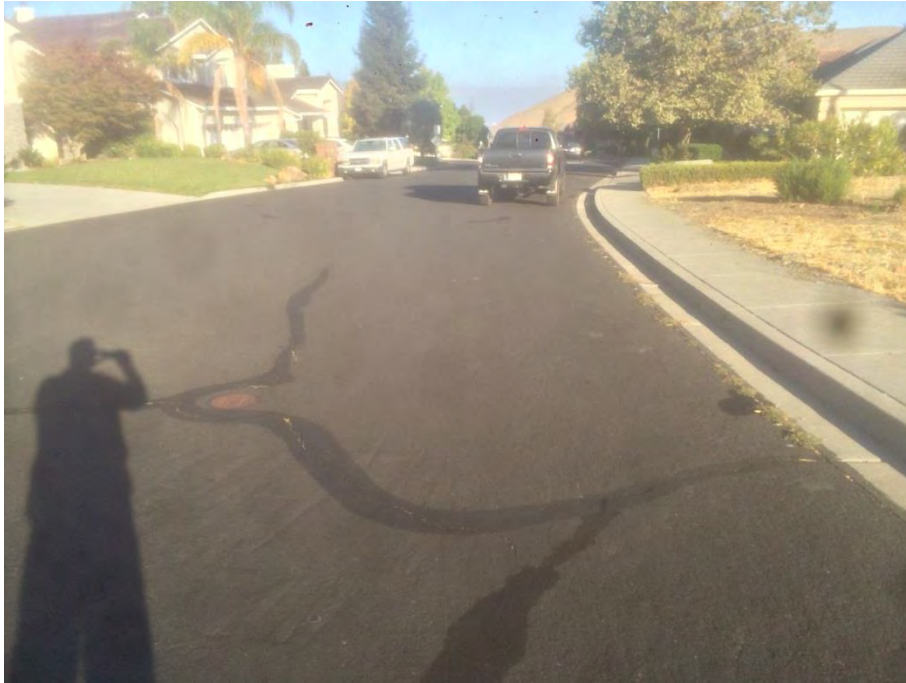
Note: That some cracking of the AC Pavement was noted in Pebble Beach Drive as shown on the Site Plan.

Tension Cracks in AC along Pebble Beach Drive at the same location as previous observations, reopening in newer asphalt. Viewed looking northwest from southeast edge of interpreted deformation zone.

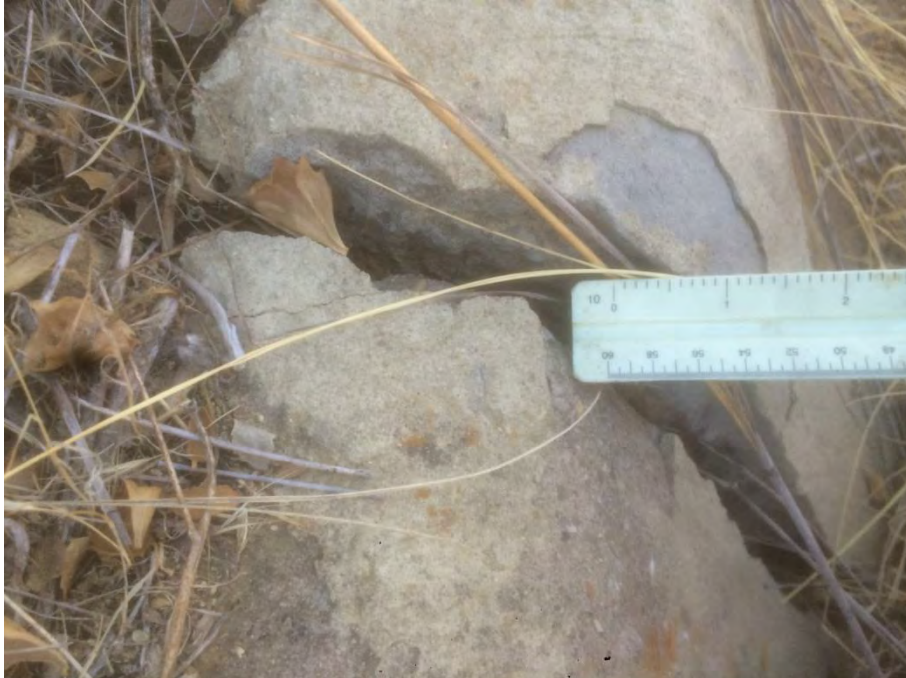
CRACK A
 $\frac{3}{4}$ inch right lateral offset at cold joint in v-ditch. This is the northernmost crack of 4 located on the mid-slope bench about 100 feet southwest of slope inclinometer.

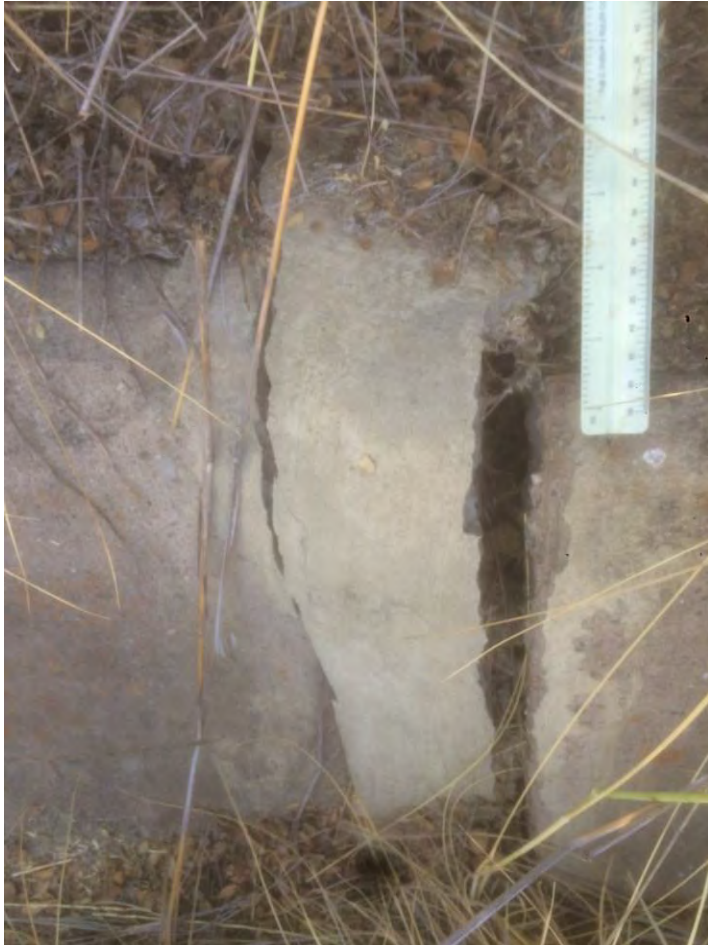
CRACK B

This is second crack from the north along the midslope v-ditch and shown up to 3 inches right lateral offset at the cold joint

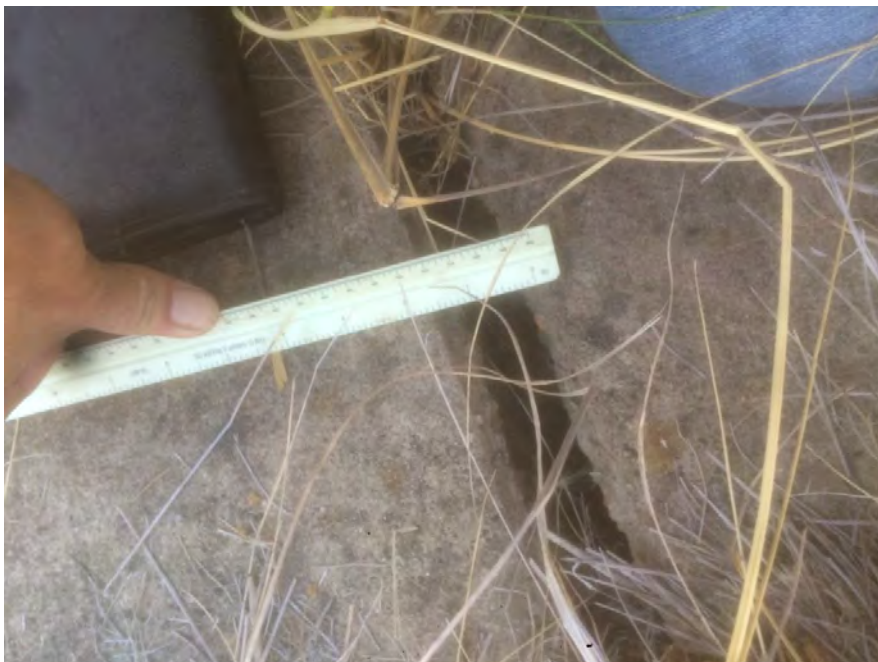
CRACK C

1½ inch dilation at the cold joint. This is the opposite end of the concrete section noted in Crack B and appears to be pulling apart due to the amount of offset occurring at CRACK B.

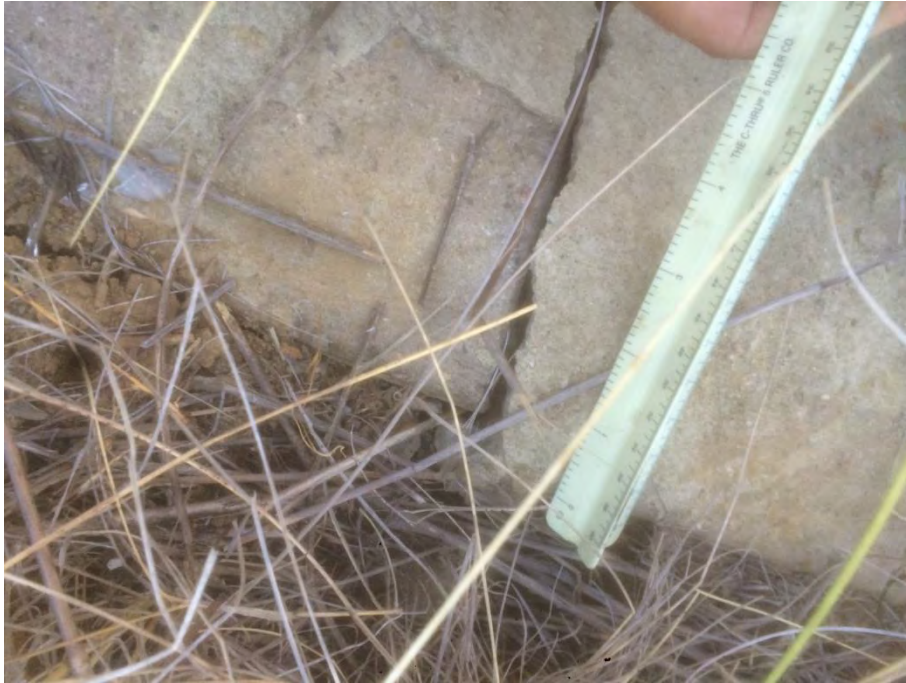
CRACK D
This is the fourth crack from the north in the series of 4. CRACK D shows about $\frac{3}{4}$ inches of right lateral offset and is the southernmost of the cracks deforming the concrete v-ditch along the midslope bench. This may be a new crack formed since my last observations, I previously only remember 3 in this location (A, B and C)

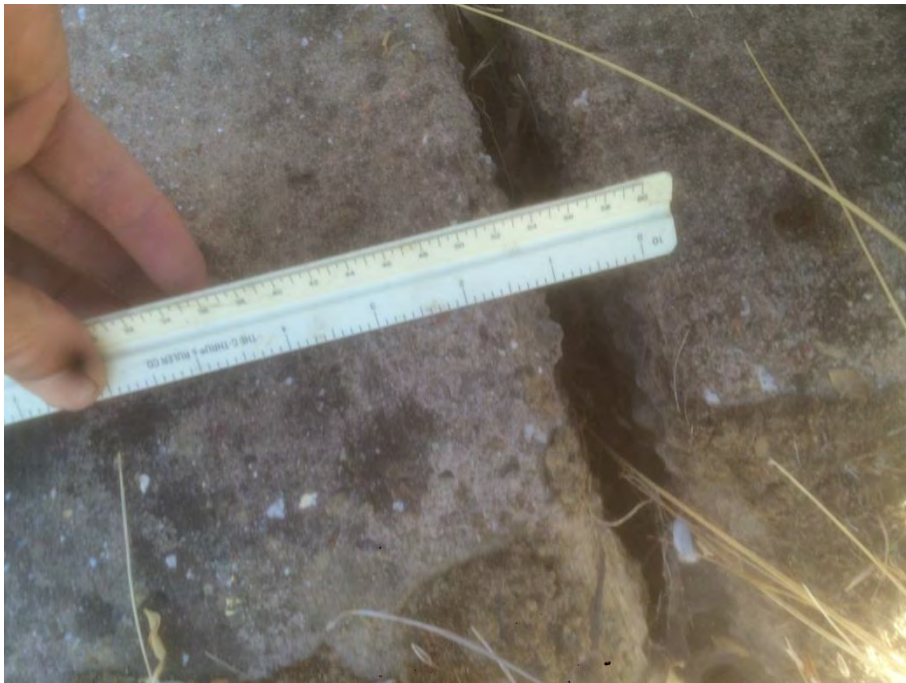
CRACK E
 $\frac{3}{4}$ inch right lateral offset and about $1\frac{1}{2}$ inches of dilation at the cold joint in the lower v-ditch.
