Trails Inventory and Evaluation

March 2008

Clayton Trails Overview

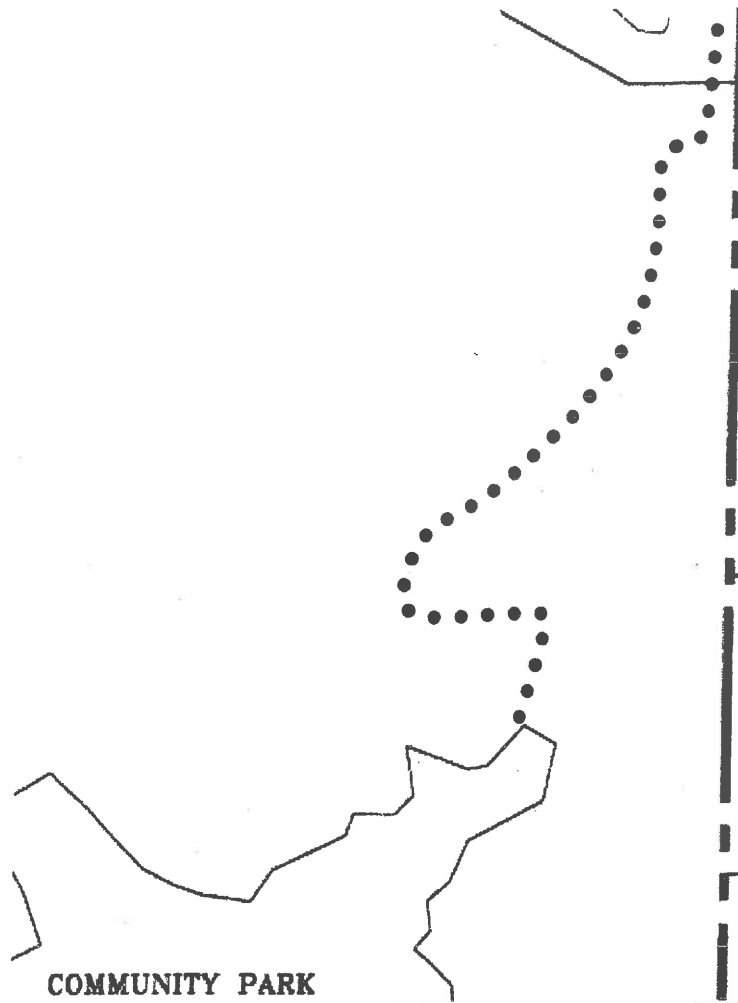
Canyon Section

Trail tread – Dirt Fire Road – 20' x 1,645' – gravel and dirt – 5'x 578' ¼ x crushed granite 2x 6 wood borders on both sides – 75% Steep grade 25% Gradual grade– Sloped cross grade.

Evaluation: This trail is a very open and friendly trail. Many hikers take their dogs along this trail. It is comprised mainly of fire and ranch roads with a ¼ x crushed granite section on a steep grade bordered and lined with water bars. This portion connects to the ridge section, and needs to be repaired to avoid future erosion of the tread slope. Better signage would greatly enhance this trail visibility.

- Add 10 yds crushed granite
- Replace or repair 10 water bars
- Replace approx. 100' of border along trail
- Repair or replace 8x8 wood marker

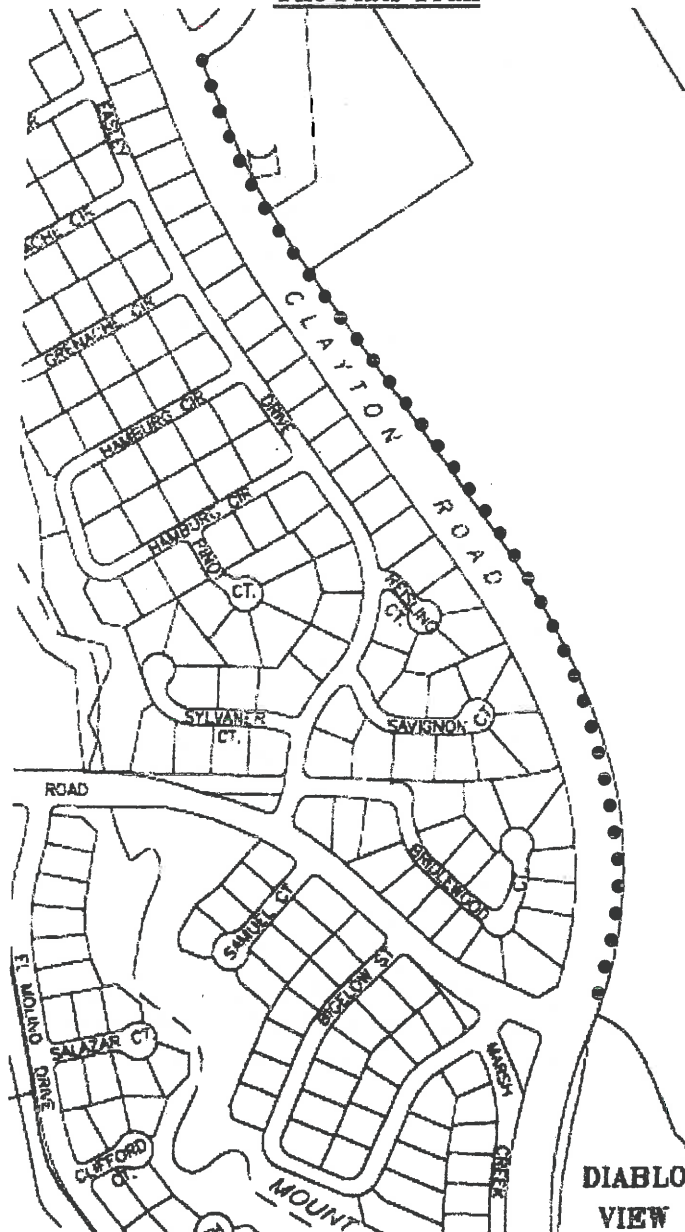
The Flats Trail

Trail tread – ¼ x crushed granite – Double sided 2x6 wood border – 4’ wide x 2,787’ long – Level grade – Sloped cross grade.

Evaluation: Areas where the trail has a steeper cross grade would need to maintain the border, but areas where the trail is wide can be eliminated. This would also aid in the annual mowing which often times destroys the border sections that have been lifted. Adding $\frac{1}{4}$ x crushed granite will give this trail a fresh new look.

- Add 20 yds crushed granite
- Replace approx. 1000' of border along trail

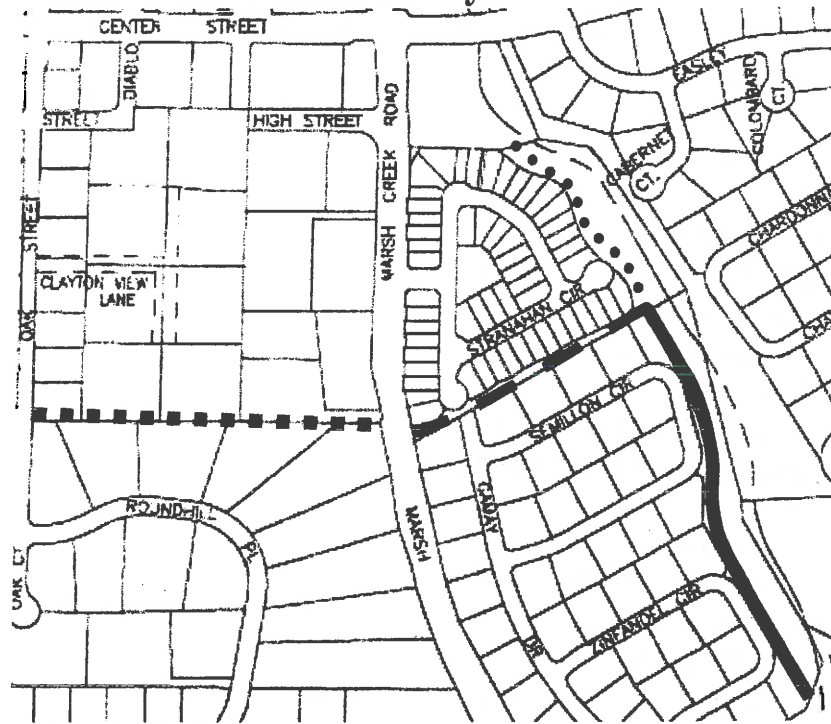
Lower Easley Trail

Overview: The **Lower Easley Trail** is a small neighborhood trail that leads to many surrounding areas including **Upper Easley Trail**, **Mudville Path** to the downtown area, and **Stranahan Path** to Marsh Creek Rd. It stretches north and south leading from the Easley Estate to Stranahan subdivision following along Mt. Diablo Creek. A (Connector path) allows you to cross a bridge and continue up to Upper Easley Trail. The south end of the trail is where Donner Creek flows into Mt, Diablo Creek, and the north end of the trail divides into 2 separate trails that lead to Marsh Creek Rd. and the downtown area.

Evaluation: This trail is in fairly good shape. There are some block cracking covering most of the trail. Crack sealing the entire path added to a new chip seal surface would keep this trail looking good for years to come. Many oaks have been planted in the last 5 -10 years in this section of trail. These oaks will need to be trimmed away from the trail in the near future.

- Crack seal entire length of path
