Re: Geotechnical Observation and Testing – Final Report
Kelok Way Dewatering Wells, Clayton, CA
SFB Project No.: 555-1

Kelok Way Wells Layout "As-Built"
 Clayton, California
 (REVISED DECEMBER 10, 2012)

Figure 2, Photo of Collector Box Interior

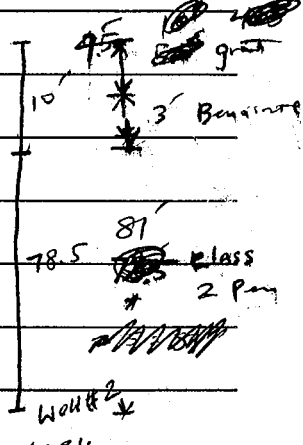
Onsite to observe drilling of dewatering well #2. PCDC was at about 105' when I arrived. Mike showed me some cuttings they collected that indicated pale grey and yellowish brown sands. The cuttings at 110' indicated dark grey to black clays. After clearing the hole with bucket barrel ^{to 110'} PCDC started installing 6" well casing and 2.75" ϕ inclinometer casing. PCDC lost the bottom @ 22.5' of the hole. I called Ken of SFB let him know the issue. Ken is okay with that they cut the well casing but replace the top 10' section with solid pipe since this well is one of the 3 wells closely spaced. PCDC should try to install 110' full length in the other two wells. The construction of this well is shown to the right. 6" PVC SDR ²¹ pipes were used for well casing. Class 2 per were placed to 7.5' below ground. PCDC is going to drill well #3 so they can retrieve the 25' casing from well #2. They will continue to drill well #3 tomorrow. ~~According to Justin, that they pulled out the casing the top of class 2 per was at about 10' below ground surface.~~

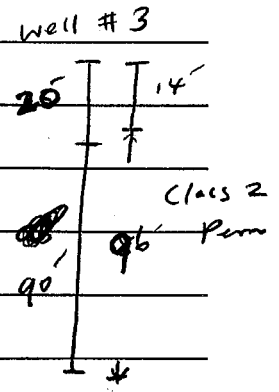
ON SITE to observe drilling of dewatering well.
PCDC was at about 110' ^{at well #3} when I arrived and started to switch to bucket barrel to clean the hole. According to Justin, they didn't encounter any pale gray sands in this hole. They started this hole this morning at 25' ^{where they lost yesterday} and ~~se~~ added polymer at about 40'. He believed this hole is cleaner than well #2. According to Justin, they started to see dark gray to black ~~clay~~ cuttings at about 80'. The carry at 110' indicated ~~indicated~~ mottled yellow grayish brown clays. PCDC used the bucket barrel to clean the hole to 110' and started to install well casing right away. ^{well} The casing went in to about ~85' then became buoyancy. ~~PCDC~~ PCDC added ^{clean} water to the casing to counter weight buoyancy. Class 2 Permeable was filled to about 14' below ~~the~~ ground.
